B-2605

POPPLETON HISTORIC STUDY

802-852 W. Fairmount Avenue

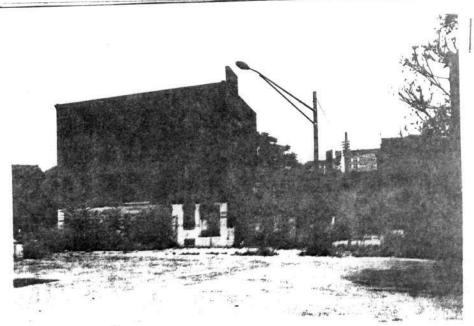
802/812

This is a nice little group which might be rehabilitated. Number 840/844 is a small auto repair garage; the others are occupied and neatly kept. There is a sallyport at 852. Below 814, at 812/802, is the four-story burned out industrial warehouse. The houses east of this are back buildings of 10 N. Fremont.

Demolished
